DEVELOPMENT OF REPAIR PROCESSES
AND SOURCES FOR C/KC-135 AIRCRAFT
WINDOWS/WINDSHIELDS

BATTELLE
505 KING AVENUE
COLUMBUS, OH 43201

SEPTEMBER 1994

TECHNICAL REPORT FOR 09/91 - 01/94
C/KC-135 FINAL REPORT
CONTRACT NUMBER FO9603-90-D-2217-SD02

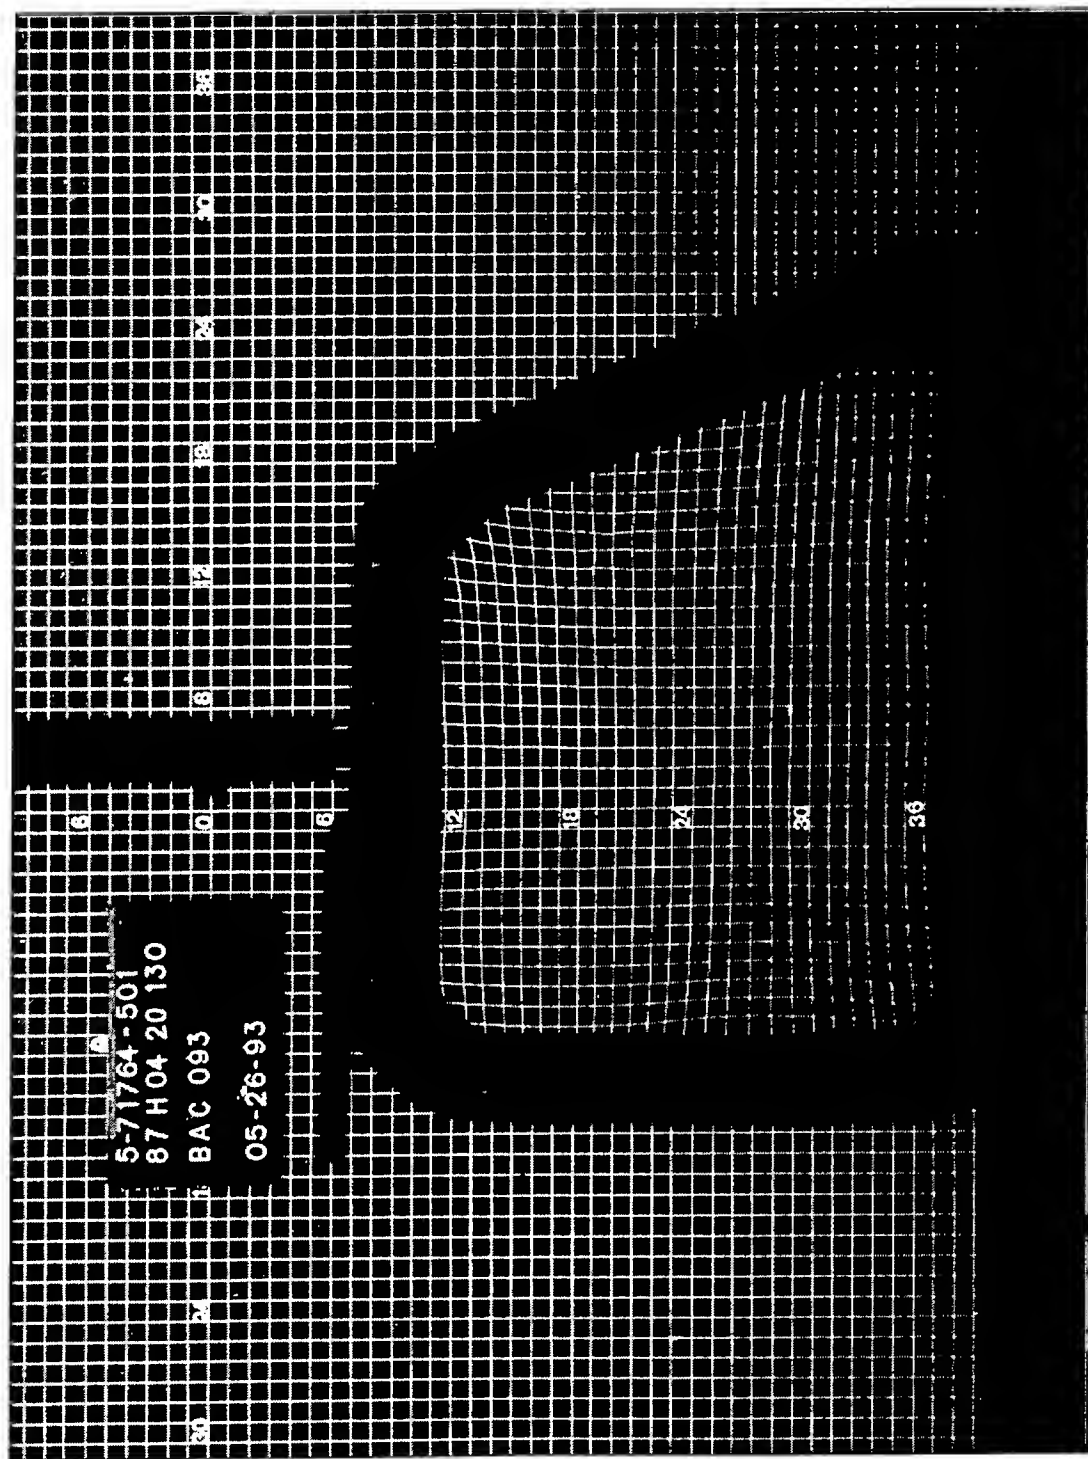
Figure 4.3 Worst Optical Distortion Found in Any C/KC-135 #1 WWS (S/N 83-H-11-7-432)

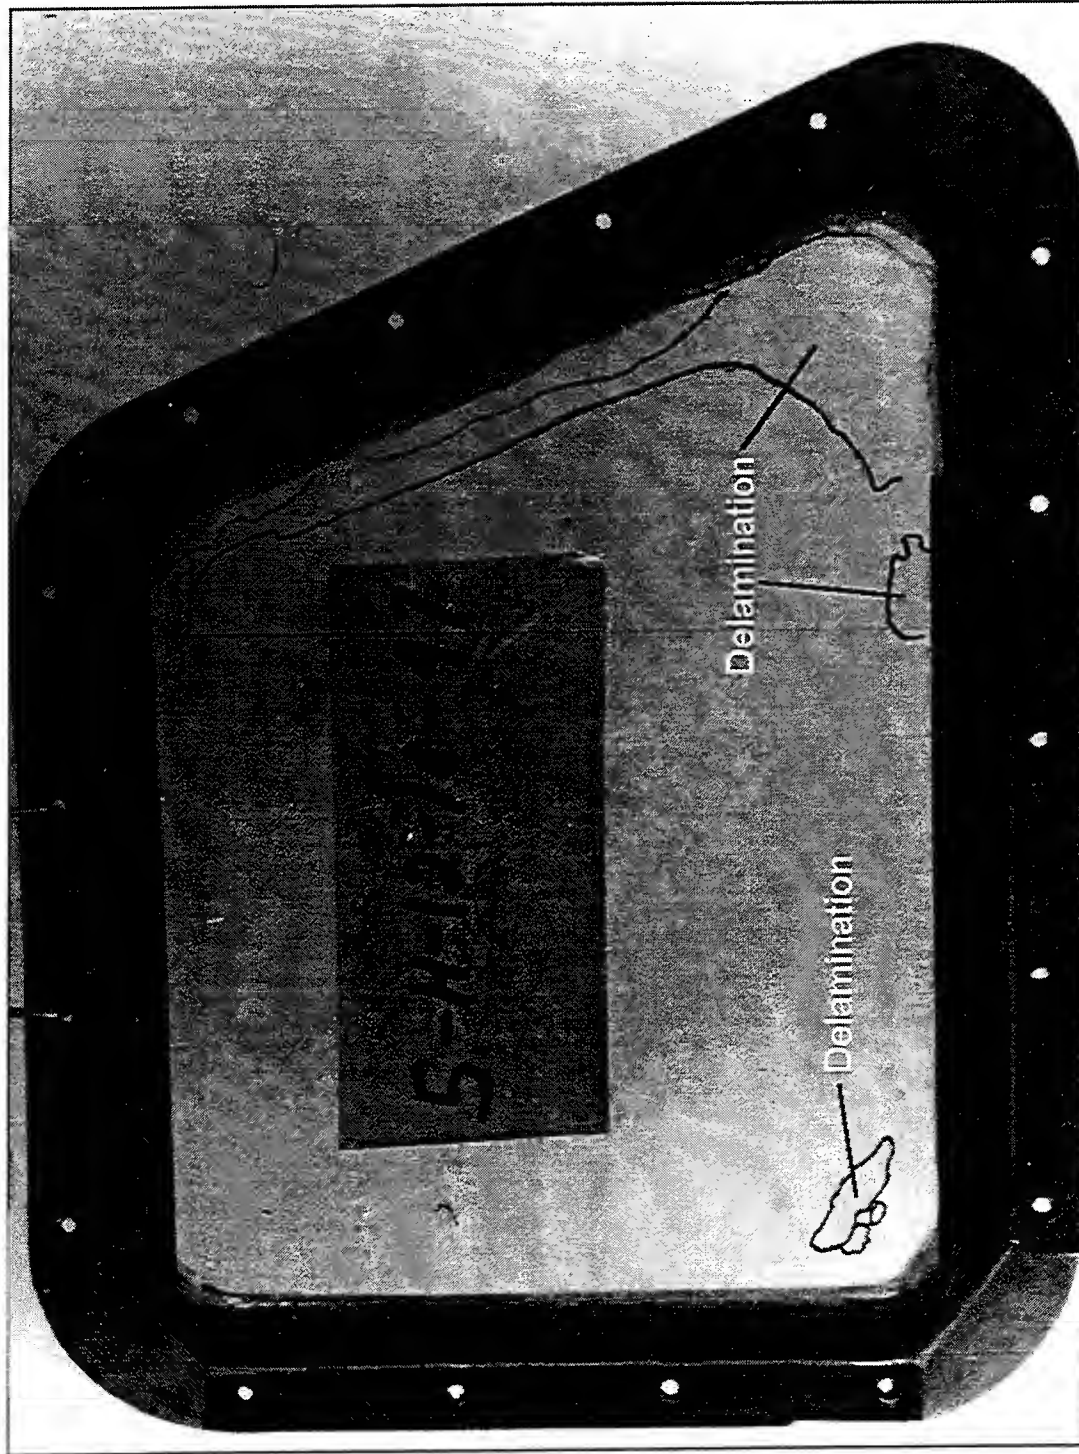
Figure 4.11 Worst Delamination Observed in a C/KC-135 #1 W/WS From Pressure Cycling (Repaired W/WS, S/N 82-H-09-06-537)

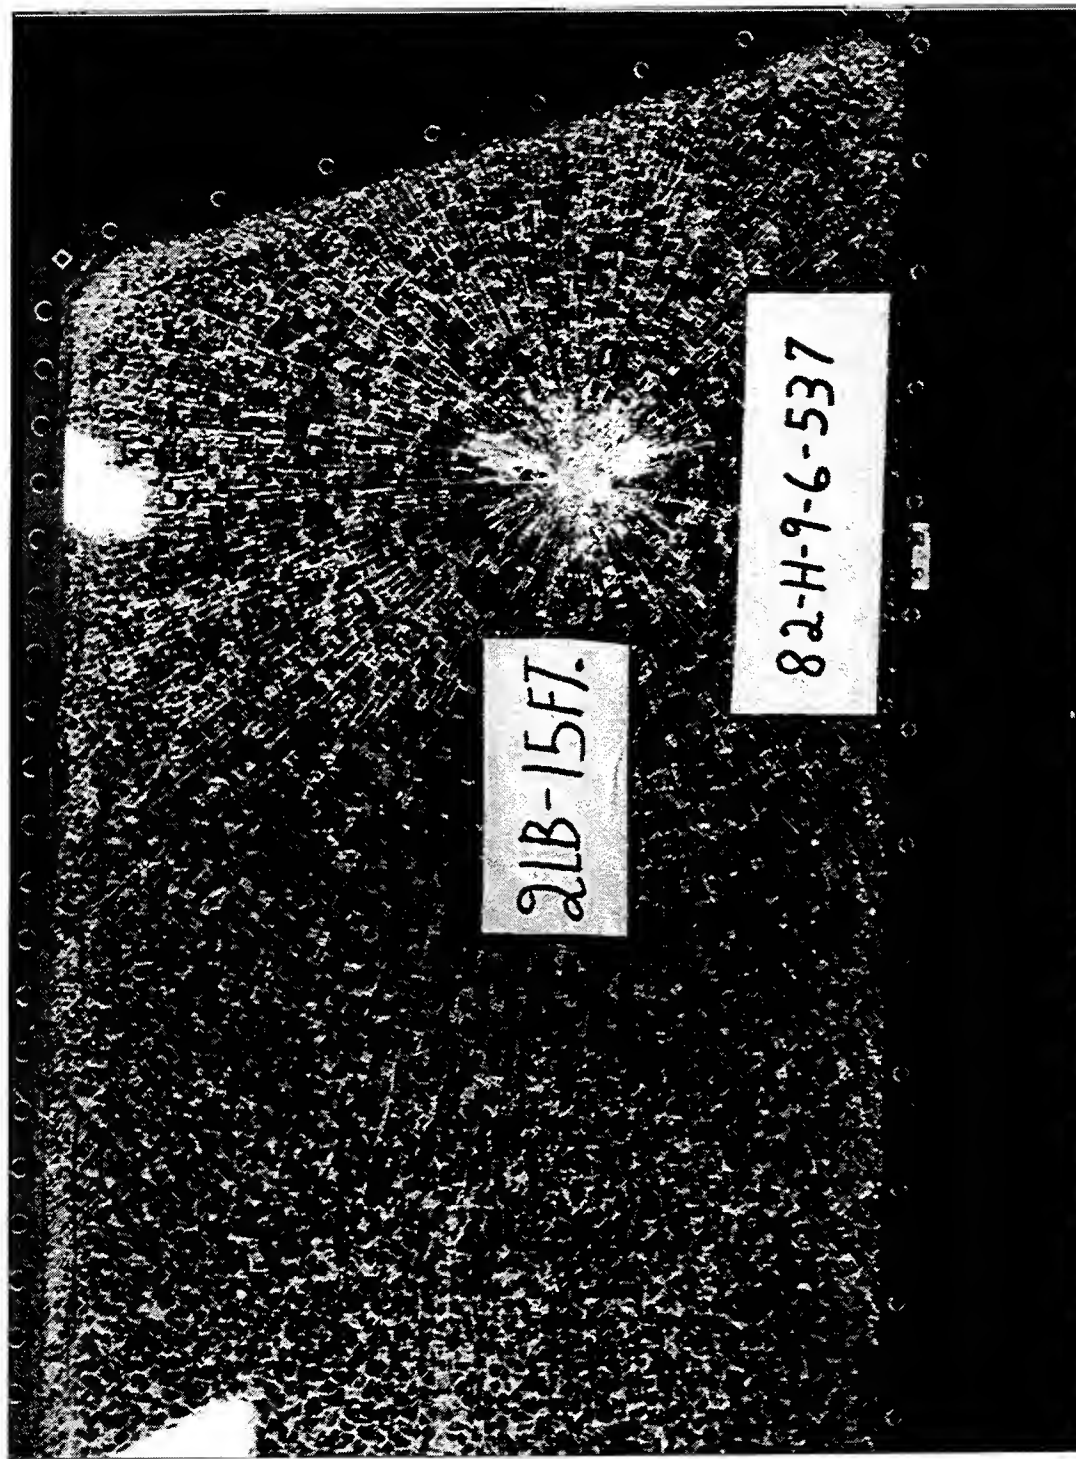
Figure 4.15 #1 W/WS Residual Strength Falling Ball Impact Test Result for a Repaired and Subsequently Delaminated W/WS, Single Ball Drop, Outboard View (S/N 82-H-9-6-537)

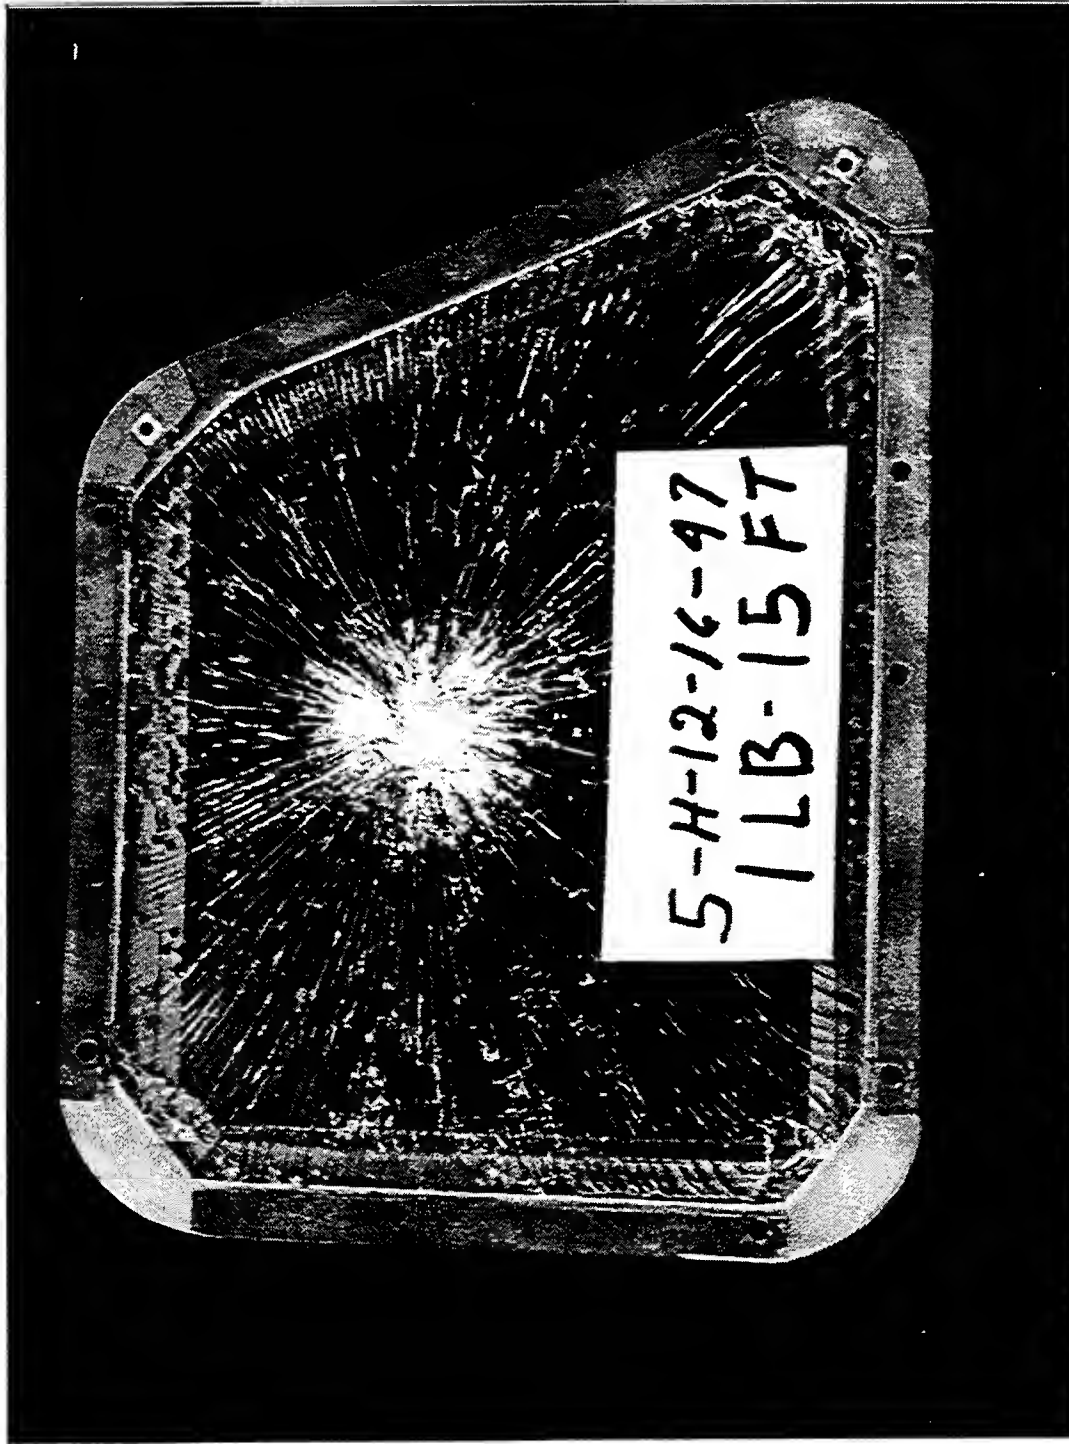
Figure 4.18 #4 W/WS Residual Strength Falling Ball Impact Test Result for a Repaired and Subsequently Delaminated W/WS, Outboard View
(S/N 5-H-12-16-47)

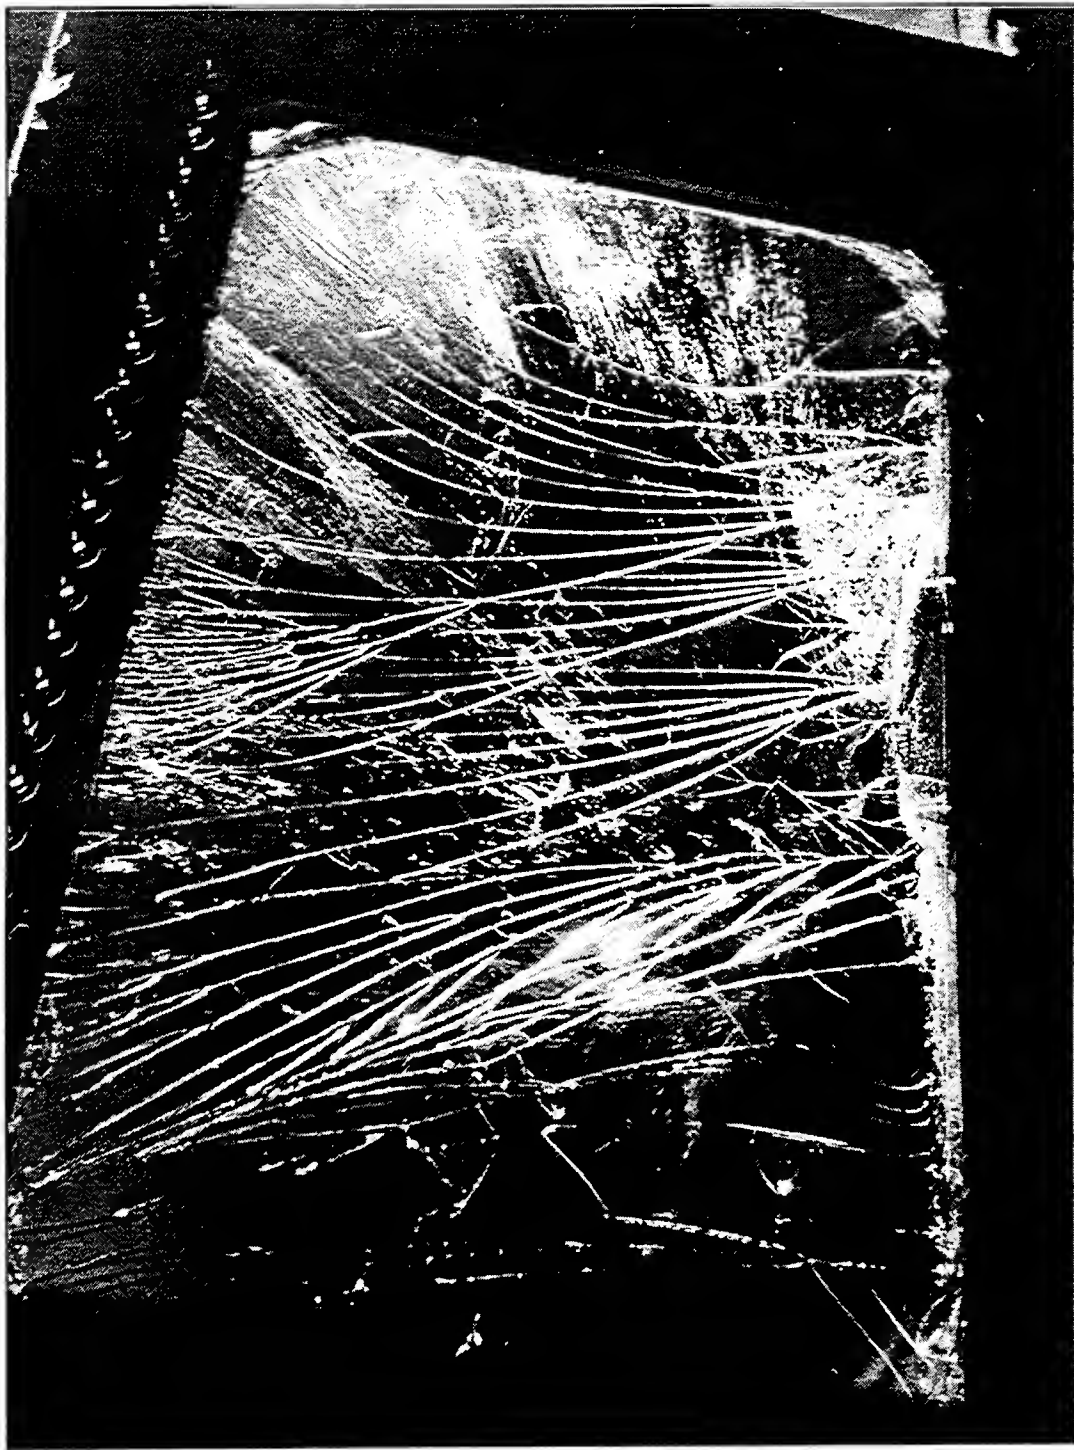
Figure 4.30 C/KC-135 #1 W/WS Showing Outboard Ply Failure From a 4-Pound Bird Impact at 251.7 Knots, Front View (New W/WS, S/N 86-H-10-06-007)

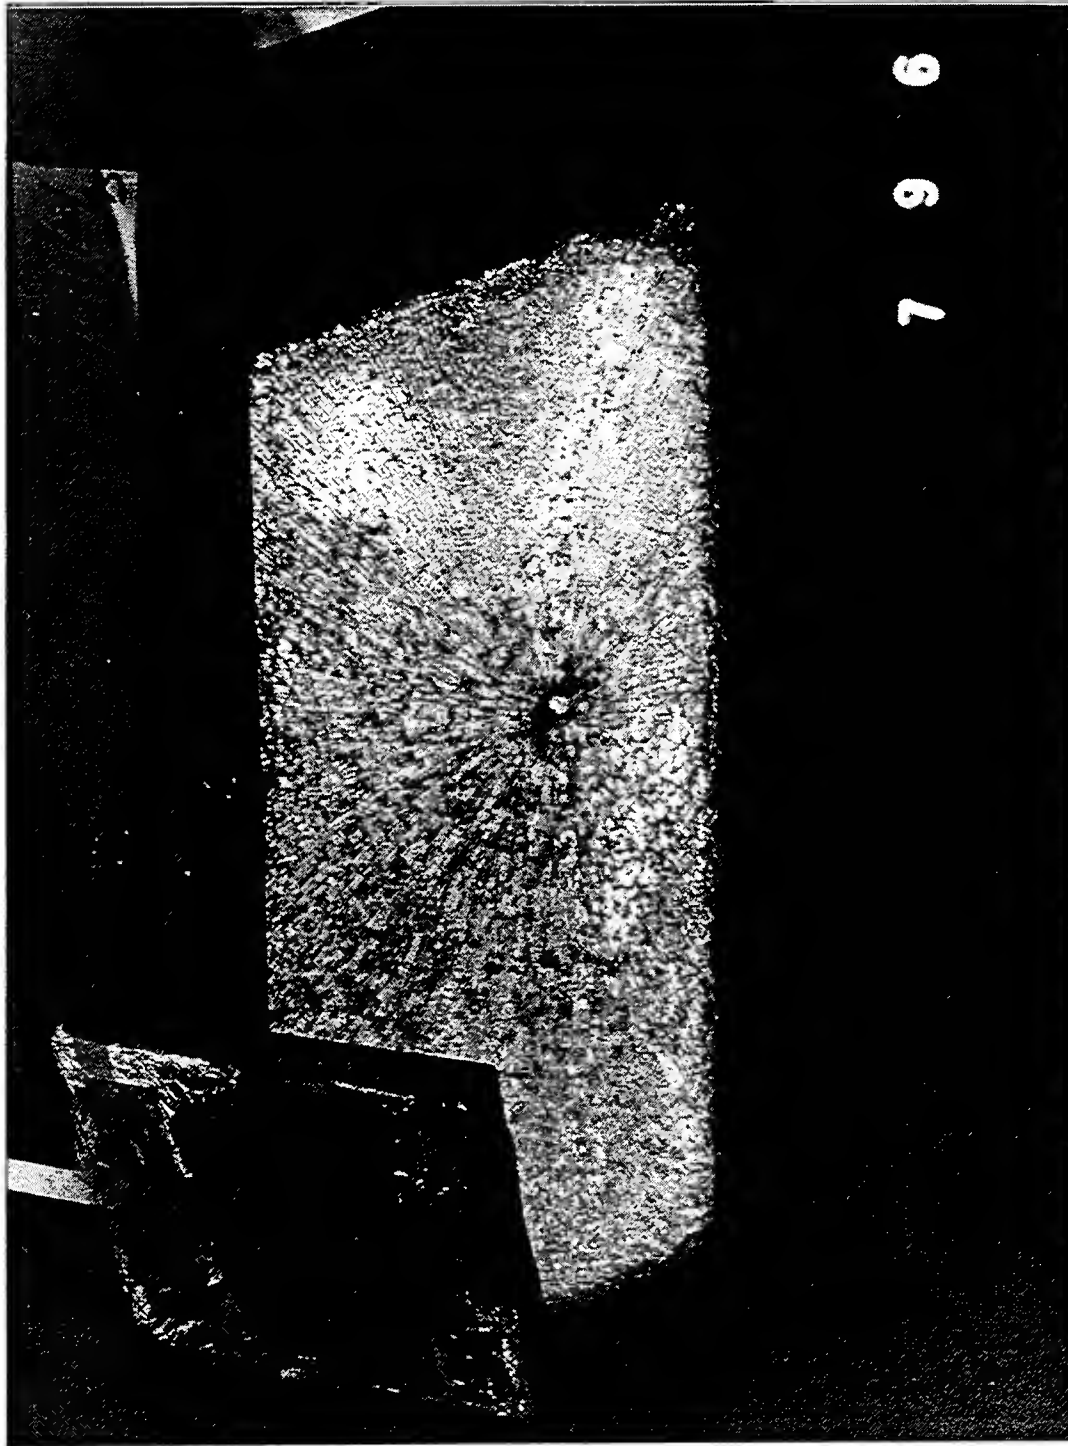
Figure 4.32 C/KC-135 #1 W/WS Showing All Glass Plies Failed From a 4-Pound Bird Impact at 249.4 Knots, Front View (Repaired W/WS, S/N 82-H-10-18-107)

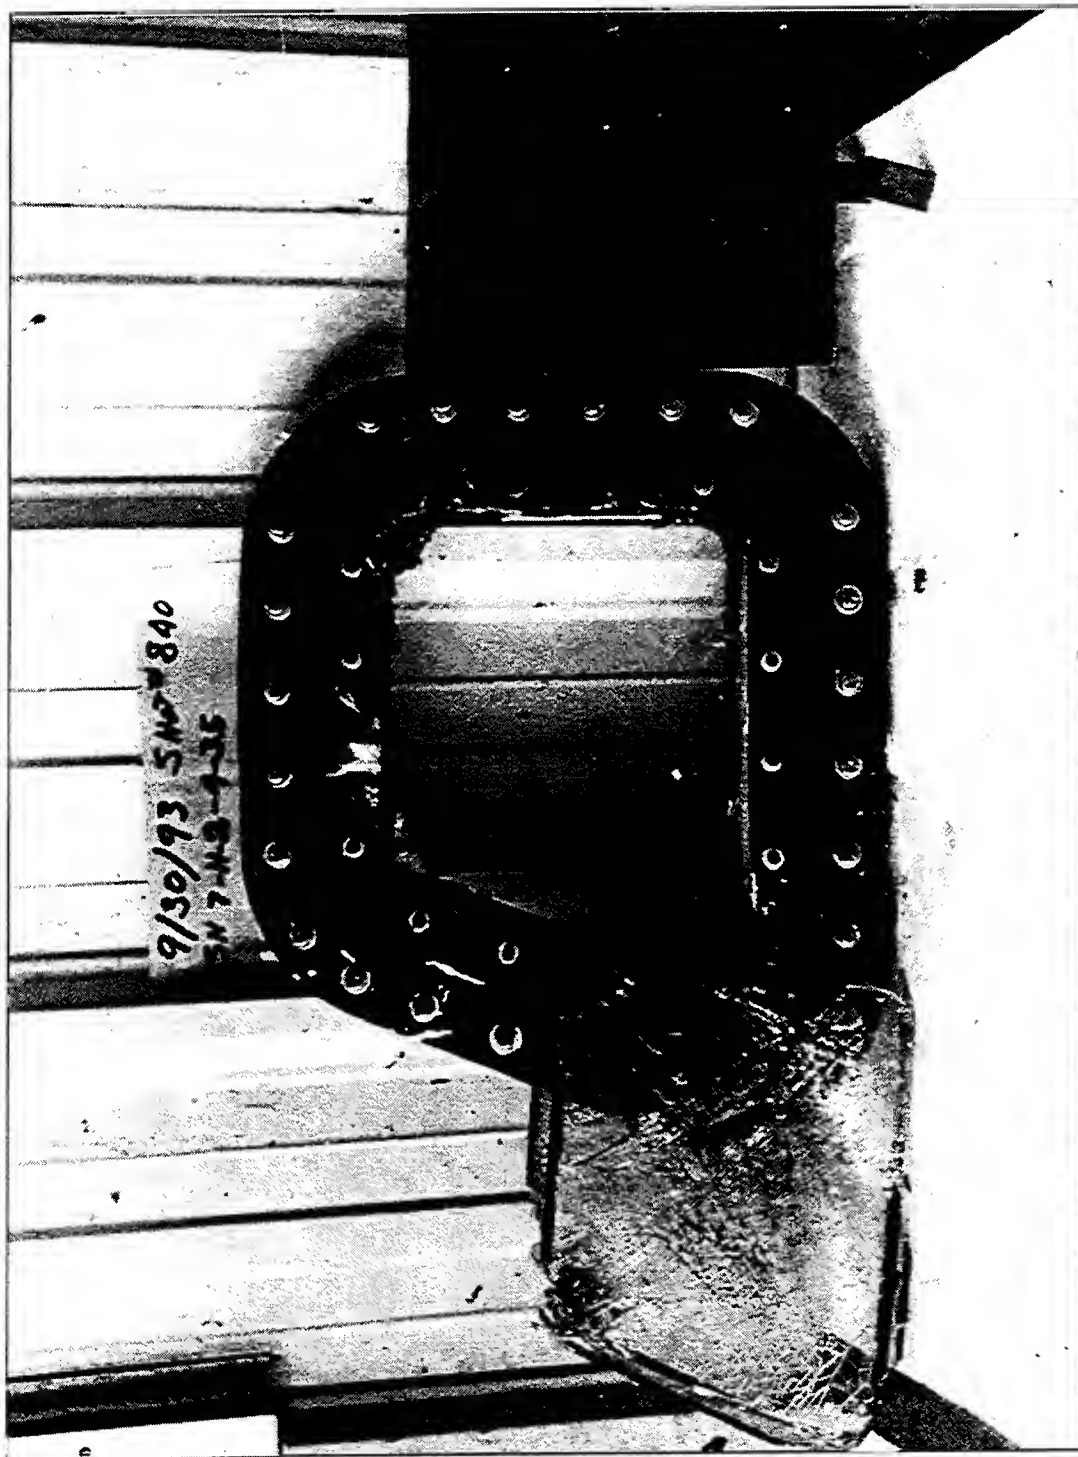
Figure 4.39 C/KC-135 #4 W/WS Showing a Catastrophic All Glass Plies Failure From a 4-Pound Bird Impact at 250.8 Knots,
Rear View (Not Repaired W/WS, S/N 7-II-2-4-35)

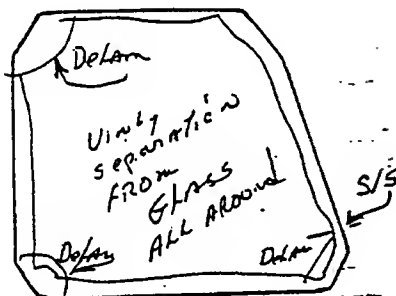
Vinyl separation from Glass edge ALL AROUND unit inside.

Delam AROUND unit in corner unit has surface scr. Remover Between ply.

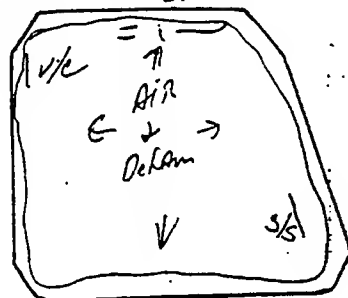
AIR & DeLam = Located ALL AROUND UNIT

Vinyl CRACK located AS MARKED

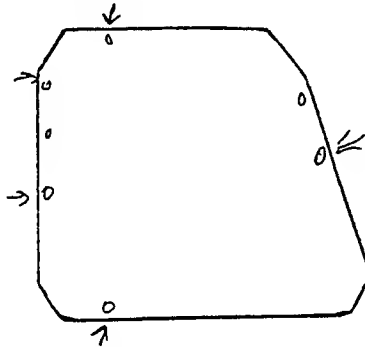
Seal Loose AS MARKED

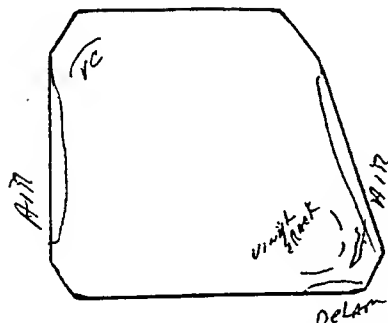
AIR Located ALL ROUND UNIT. plus A Large Amount Located Lower/Fwd. Along with delam Also Vinyl cracks believe to be starting

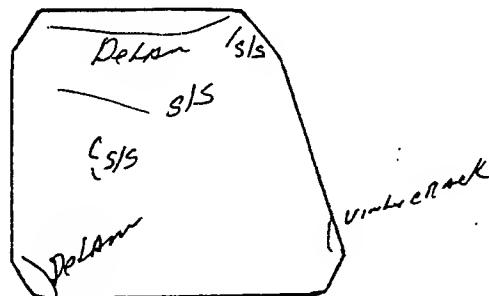
Delam as marked
surface SCR, as marked
vinyl crack as marked

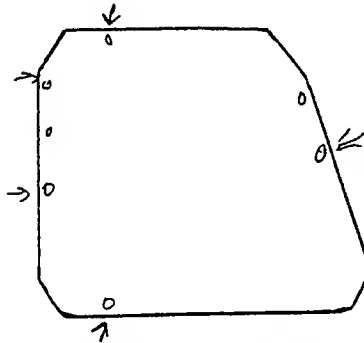
Seal Loose AS MARKED

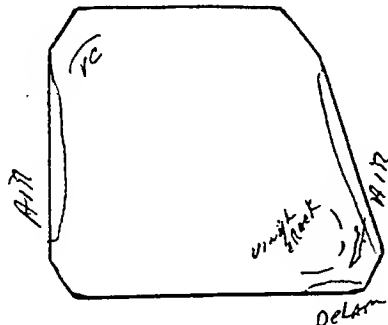
AIR LOCATED ALL ROUND UNIT PLUS A LARGE
 AMOUNT LOCATED LOWER/FWD. ALONG WITH DELAM
 ALSO VINYL CRACKS BELIEVE TO BE STARTING

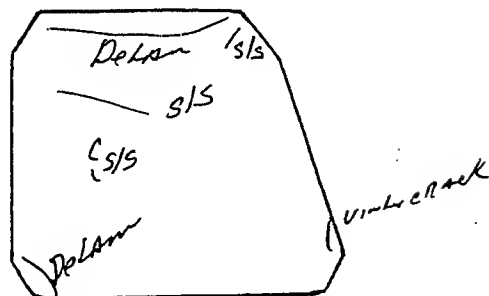
Delam as marked
 surface SCR, as marked
 vulcrack as marked

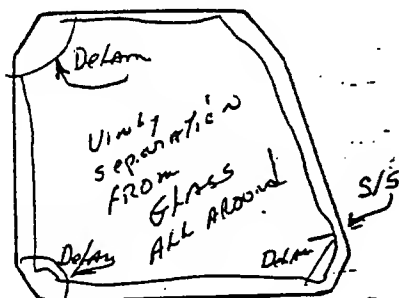
Vinyl separation from Glass edge ALL AROUND unit inside side.

Delam AROUND unit in corner unit has surface scr. Remover Between ply.
